STRUCTURAL HEALTH MONITORING OF WATER TANK BY NDT MECHANISM

destructive tests. The tank is located in **Ambegaon (BK), Dist. Pune**. The tank is built in year 1976 and storage capacity of tank is 75,000 litres. This structure consists of 6 circular columns. The tank is owned and maintained by **Nagar Parishad Ambegaon** since from last 40 years. Staging height of water tank is 10.5 m. Structural geometry of tank is with top spherical dome, cylindrical/vertical wall, conical dome and bottom flat with two stage bracing levels. Typical view of elevated service reservoir is as shown in figure 2.

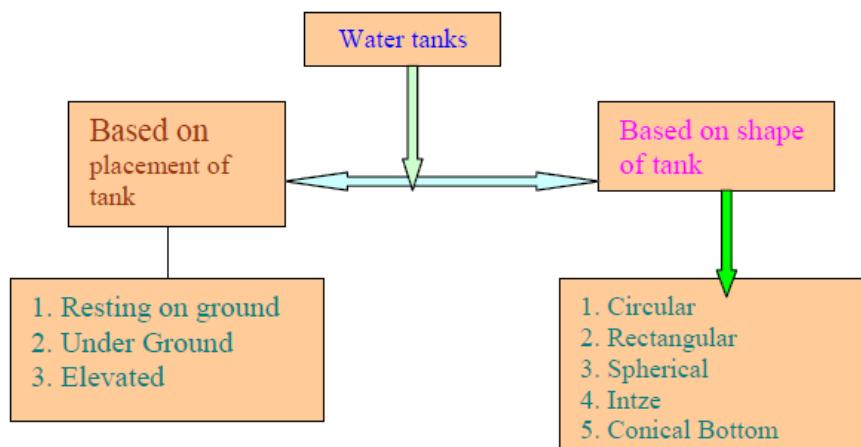
Fig -1 Classification of water tank

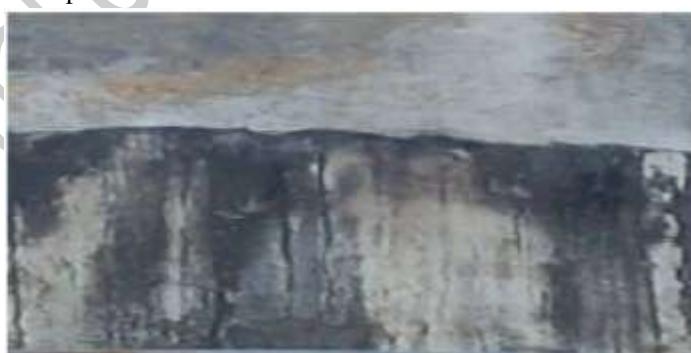
- a) Blackish patches were seen on dome periphery as shown in figure 3.
- b) Corrosion damage of ring beam inner side of ESRs shown in figure 4.
- c) Bottom reinforcement of bracings were exposed and corroded as shown in figure 5.
- d) Longitudinal cracks were seen on columns as shown in figure 6.

Fig.3 Blackish patches on dome periphery

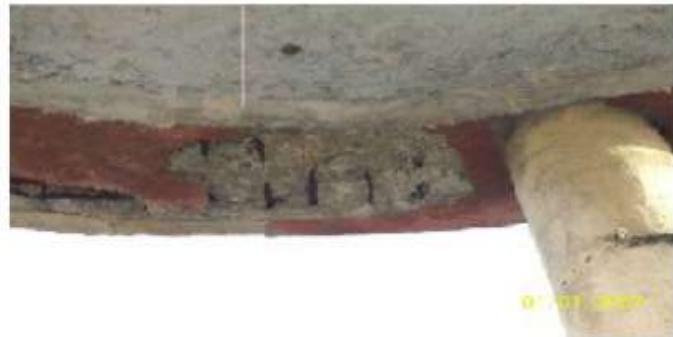
Fig.4 Corrosion damage on Ring Beam inner side

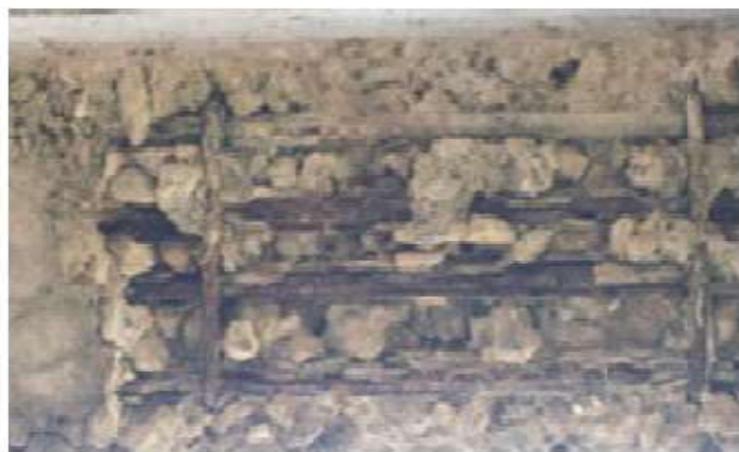
Fig.5 Bottom reinforcement exposed

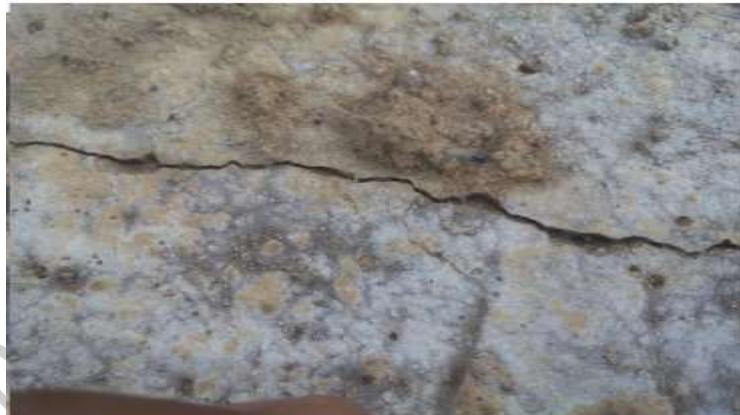
Fig.6 Longitudinal cracks on column corroded

- Propping the beams on all the sides of the columns for full vertical height. The props shall be able to take the total load coming on to the column.
- Chipping open the cover concrete until all the corroded steel rods are and cleaning of rods with brush

- Chipping the spelled surface of concrete to remove all loose materials. Then brushing it with steel wire brush to remove all loose particles. Washing the surface with potable water.

- Leak proof formwork which should not deform or leak due to pressure of concrete shall be fabricated and erected in position. The formwork should be coated with mould release agent prior to the final fixing in position. Making proper supporting arrangements for keeping the shutter in correct line and length.
- Encasement using high slump concrete of grade M25 (minimum).It shall be ensured that clear cover to the new steel is 50mm. Curing compound is to use for curing purposes.

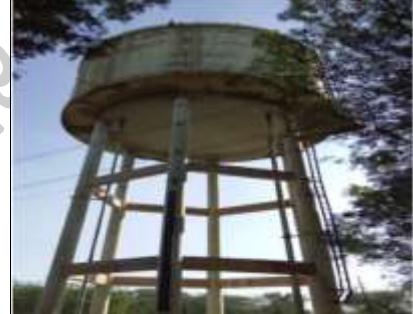
| Sr. No | Location | Name of Distress | Photos |
|---|---|---|---|
| 01 | Outer wall of water tank C-3 & C-4, Outer wall of water tank C-5 & C-6, Outer Slab near C-1,C-2,C-3,C-4,C-5 | Patch of dampness | Figure 1 |

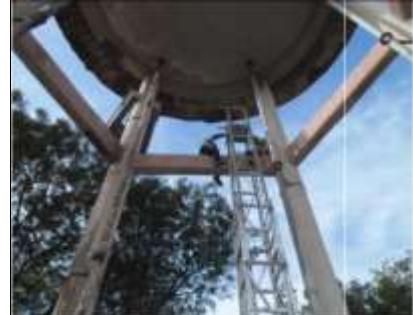
| Sr. No | Location | Name of Distress | Photos |
|---|---|---|---|
| 02 | Inner wall of water tank above C-1, C-2 | Water Seepage | Figure 2 |

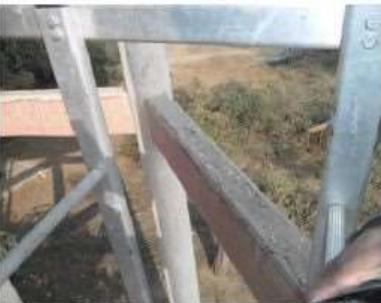
| 03 | Vertical Cracks in bottom and middle parts of Column No. C-1. Horizontal cracks from bottom to top in Column No. C-2, C-3, C-4, C-5, C-6. Vertical cracks in bottom and middle parts of Column No. C-3, Beam No. B-2, B-4, B-5, B-6, B-7, B-8, B-9, B-10, B-11 | Moderate Cracks (5mm to 10mm) | | Figure 3 |

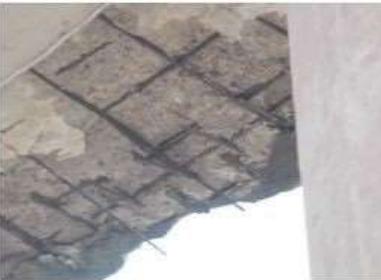
| 04 | Bottom Part of Column C-1, Middle part of Column C-1, Bottom Part of Column C-2, Inner side of Beam B-2, Soffit of Beam B-8, B-3, B- 1, Patches in outer slab | Corroded Reinforcement | | Figure 4 |

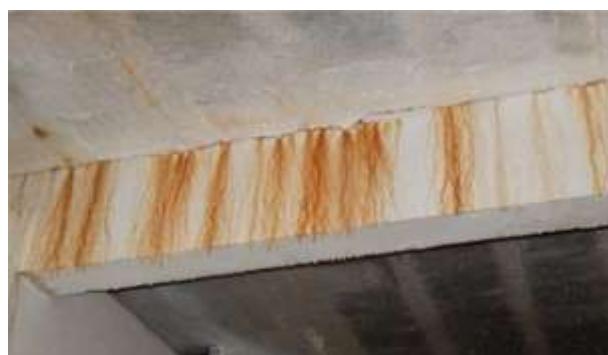
**Fig 7 water tank pathology cracking**

security level and to help the meaning of the basic retrofitting and recovery needs. No significant harms were recognized in the auxiliary components assessed. Notwithstanding, splitting was seen of the top piece that permits the penetration of water into the tank along with a deficient slant for water waste and a raised debasement of the waterproofing layer. It varies hour to hour. So as to gracefully steady measure of water, we have to store water. So to satisfy the open water need, water tanks should be built. These tanks are planned according to Seems to be: 3370 for example Code of training for solid structures for capacity of fluids. BIS actualized the reconsidered rendition of IS 3370 (section 1& 2) after quite a while from its 1965 form in year 2009. By and by enormous number of overhead water tanks is utilized to convey the water for open utility. A large portion of the water tanks were planned according to old IS Code: 3370-1965 without considering quake powers. Structures are congregations of burden conveying individuals prepared to do securely moving the superimposed burdens to the establishments. Their primary and most cared for property is the quality of the material that they are made of. Concrete, as we as a whole

1. Cracked or any surface of concrete which is prone to cracks are repaired with polymer modified mortar. After the completion of the project the NDT tests will be conducted again to ascertain the quality and strength of aspects improved in the structure
